University of Nevada, Reno

Examination of Gap Detailing in Drywall Partition Walls with Return Walls

**Preliminary Report of Nonstructural Phase II: Bidirectional
Subassembly Tests at Lehigh University**

Hamed Hasani and Keri L. Ryan

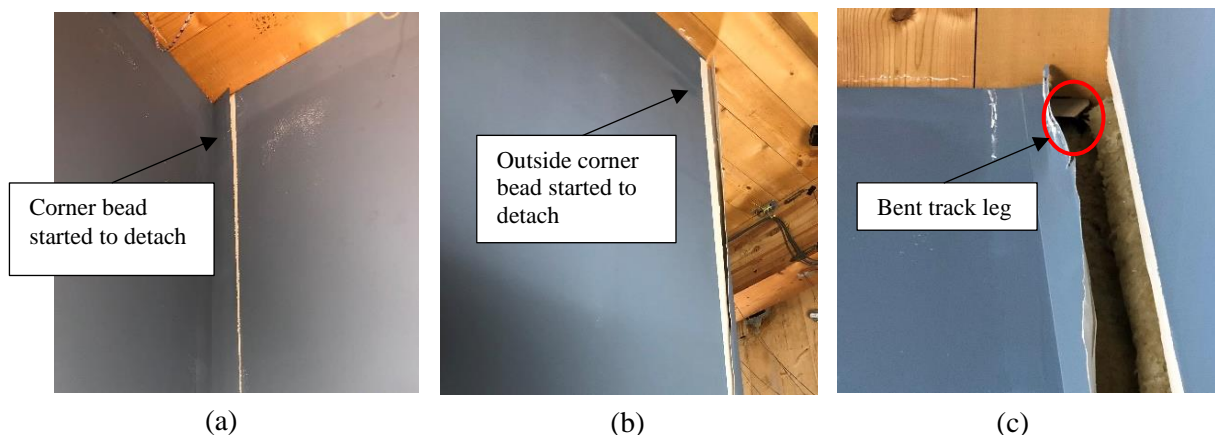
The seismic performance of the drywall partition walls was preliminarily evaluated through observation of the damage mechanisms. After each cycle, the damage to the partition walls was assessed, and a damage description recorded. Representative damage in the corner gap wall is shown in Figure 6. One of the corner beads started to detach at a 0.43% drift (Figure 6a). At 0.84% drift, all of the corner beads started opening, and the width of the opening increased as the drift was increased (Figure 6b). At 2.56% drift, the bending of the track leg in the corner gap was apparent (Figure 6c).

Figure 6: Corner gap detailing: (a) corner bead opening (0.43%), (b) opening of outer corner bead (1.05%), (c) bending of the track (2.56%)

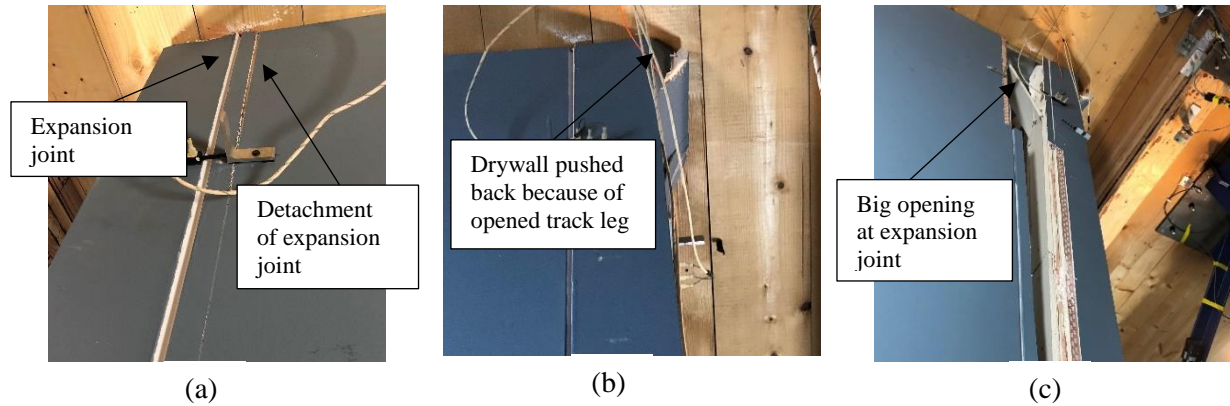
For the distributed gap wall, at 0.84% drift, the non-fire rated expansion joint adjacent to the return wall started to detach (Figure 7a). At 1.05% drift, the leg of the track at the wall intersection began to open and pushed the drywall (Figure 7b). At 2.56% drift, the distributed gap developed big openings adjacent to the return walls (Figure 7c).

Figure 7: Distributed gap detailing: (a) detachment of expansion joint (0.84% drift), (b) opening of the track leg (1.05% drift), (c) opening in the fire-rated wall intersection (2.56%)

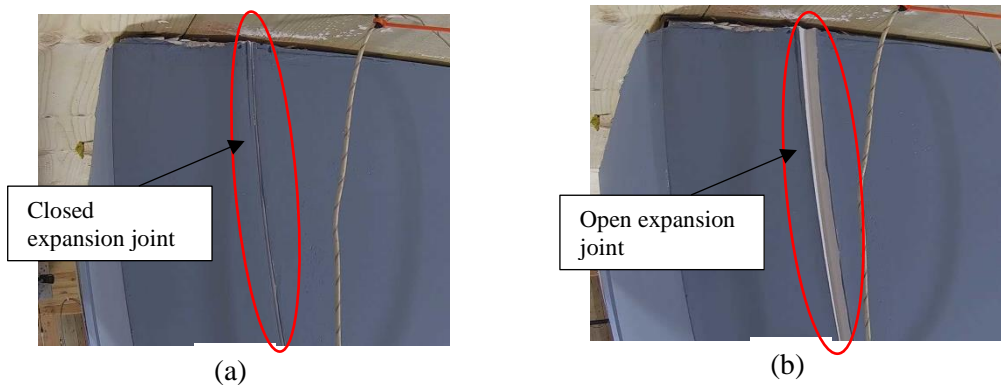
The performance of the expansion joint adjacent to the return wall is shown in Figure 8. The expansion joints were damage free up to 0.84% drift. The expansion joint closes (Figure 8a) when the return wall moves toward the main wall. When the return wall pulls away from the main wall, the expansion joint opens (Figure 8b). The expansion joint allows a total of 1-in. movement (+/- 0.5 in.).

Figure 8: (a) Closed non-fire rated expansion joint, (b) open non-fire rated expansion joint

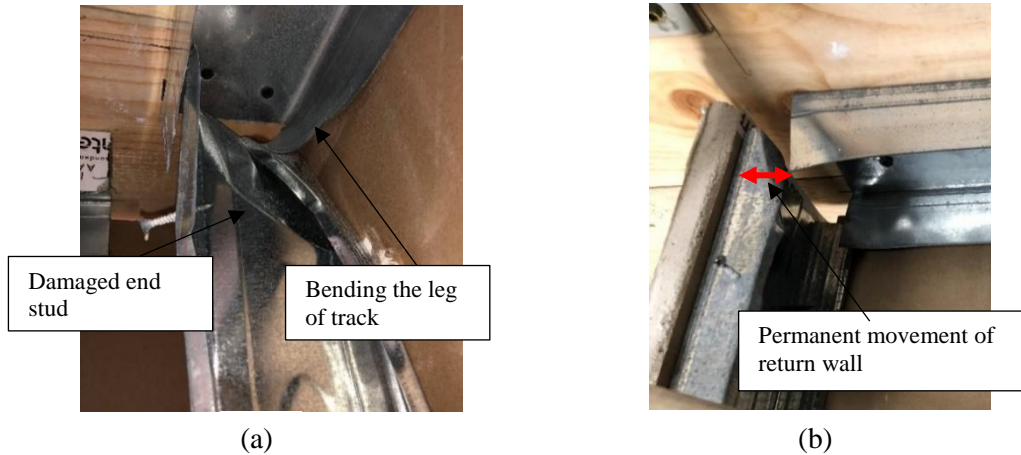
The post-test inspection of the specimens revealed the following. In the corner gap wall, end studs were damaged, and the legs of the track were bent (Figure 9a). Moreover, the return wall had permanently moved in the in-plane direction (Figure 9b). In the distributed gap wall, the return wall moved permanently in its in-plane direction for both fire-rated (Figure 10a) and non-fire rated (Figure 10b) gap detailing. Besides, in the fire-rated wall intersection, the gap in the return wall also opened, and the studs pushed out through the track legs (Figure 10c). Since the gaps on both sides adjacent to the wall intersection opened, the small corner section of the wall became unstable. Damage in the non-fire rated wall intersection for distributed gap detailing is shown in Figure 10d, which included the opening of the track leg and studs being pushed out of the track.

Figure 9: Different damage states observed in the post-test inspections of the corner gap wall: (a) damage in the end stud and bending of the track leg, (b) permanent movement of the return wall in the in-plane direction

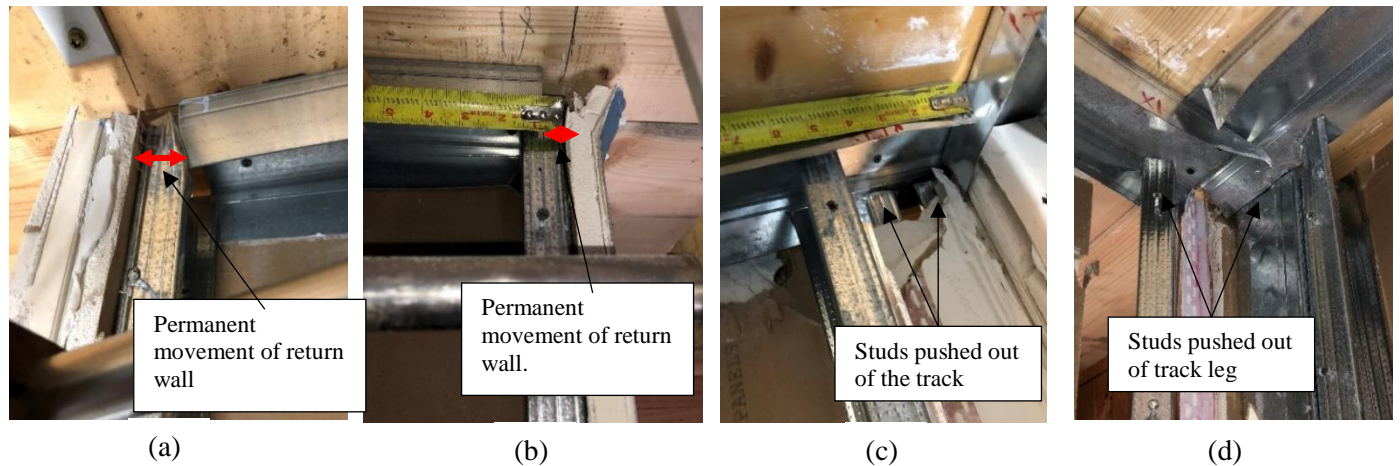
Figure 10: Different damage states in the post-test inspections of the distributed gap wall: (a) permanent movement of the return wall (fire-rated wall intersection); (b) permanent movement of return wall (non-fire rated wall intersection); (c) track opening in the return wall and pushing out of studs (fire-rated wall intersection) (d) track opening, and pushing out of studs (non-fire rated wall intersection)

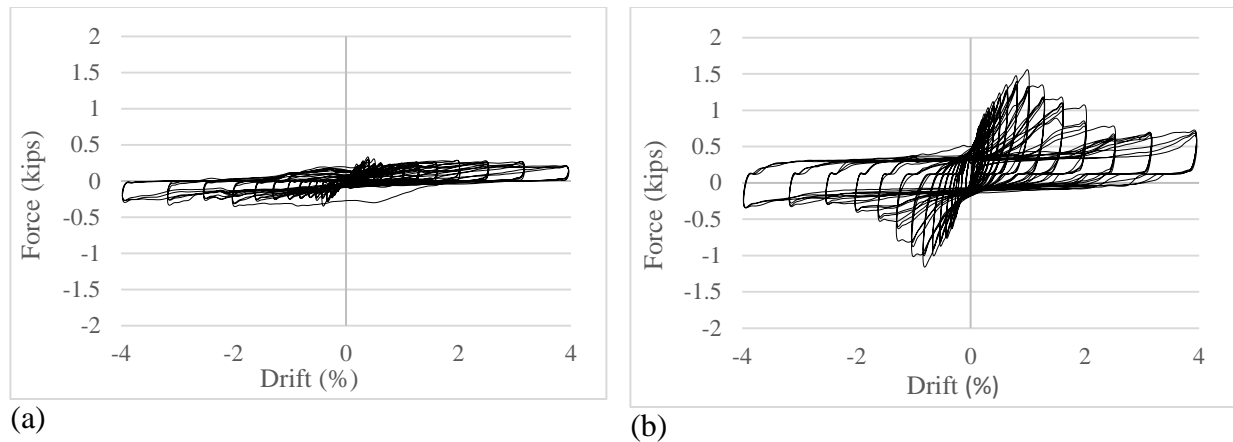
Figure 11 shows the force vs. displacement hysteresis loops of the walls with corner gap detailing (Figure 11a) and wall with distributed gap detailing (Figure 11b). Based on these hysteresis plots, the forces that developed in the corner gap wall were much lower than in the distributed gap wall because the distributed gap detailing behaved like an ordinary wall intersection after the expansion joints closed. As seen in Figure 11b, the forces dropped substantially in the distributed gap wall after about 1% drift.

Figure 11: Hysteresis loops of drywall partition walls: (a) corner gap; (b) distributed gap

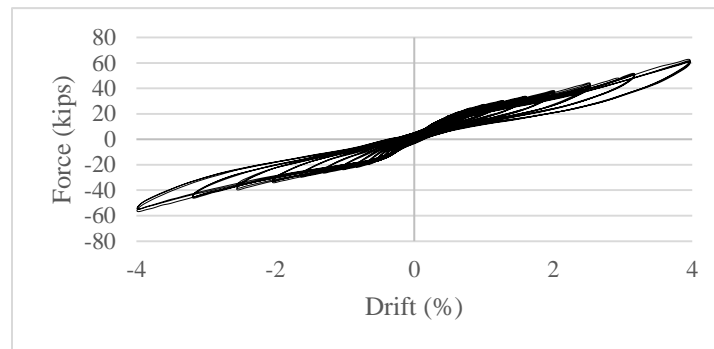
The hysteresis loop of the whole subassembly (CLT rocking wall plus partition walls) is shown in Figure 12. The contribution of drywall partition walls to the resistance of the entire subassembly was less than 3%. Furthermore, the rocking walls were damaged from the previous phases, which would effectively lower their resistance and increase the relative resistance of the partition walls. Thus, in a large earthquake with an initially undamaged lateral system, the resistance of the partition walls is practically negligible, and need not be accounted for in the design of the lateral system.

Figure 12: Hysteresis loop of building in the in-plane direction
