# **Examination of Slip Behavior in Drywall Partition Walls**

Preliminary Report of Bidirectional Subassembly Tests at Lehigh University: Phase I of Nonstructural Testing

Experiments conducted as part of NSF Grant No. CMMI-1635363 and 1635227, "Collaborative Research: A Resilience-based Seismic Design Methodology for Tall Wood Buildings"

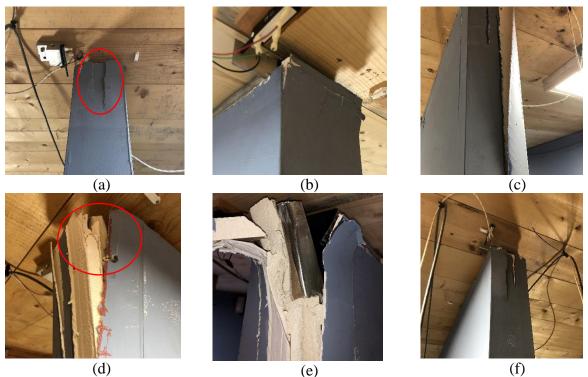
The seismic performance of the drywall partition walls was preliminarily evaluated through observation of the damage mechanisms (Figure 5). After each cycle, the damage to the partition walls was assessed, and a damage description recorded. Corner beads at the end of both walls started to lightly detach at around 0.46% drift (Figure 5(a)). This damage occurs because the entire wall below the top track tends to remain stationary, while the top track tends to move with the top diaphragm (natural behavior of slip-track). Since fire regulations permit only up to half-inch gap at the top of the gypsum (Gypsum Association 2018), while the top track leg length is 2 in. for both types of detailing, the top track hits the gypsum at the top of the wall ends.

The detachment of corner beads increased with increasing drift. Light warping of the gypsum was observed at 0.67% drift (Figure 5(b)), and the corner bead opened significantly at 0.84% in the slip-track connected wall (Figure 5(c)). Coincident with this observation at 1.26 in. displacement, the resisting force increased significantly. Since the stud leg is 1.25 in., the authors believe that the considerable opening in the corner bead is due to the stud not returning to its nested track in the slip-track connected wall. Bending of the end stud was observed at 2.56% drift in the slip-track connected wall (Figure 5(d)). At a drift of 3.2%, the damaged end stud in the slip-track connected wall bent the leg of the track (Figure 5(e)), which was coincident with a considerable increase in the resisting force. While all of this damage progressed in the wall with the slip track connection, the wall with telescoping detailing showed only minor damage at the top end of the wall (Figure 5(f)).

Figure 5: (a) Light detachment of corner bead at wall ends (0.46% drift, slip track); (b) light warping of gypsum (0.67% drift, slip track); (c) significant opening in the corner bead (0.84% drift, slip track); (d) end stud bending (2.56% drift, slip track); (e) track leg bent (3.2% drift, slip track); (f) light detachment of corner bead at wall ends (1.64% drift, telescoping)

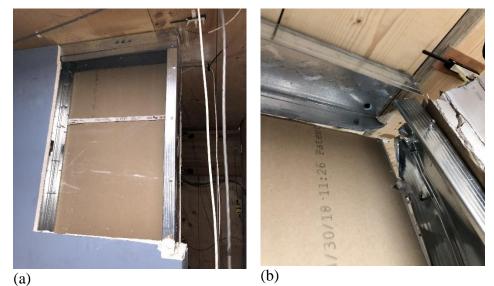
The post-test inspections suggest that the framing of the wall with telescoping detailing remained damage-free during the test (Figure 6(a)). However, the stud and track of slip-track detailing suffered damage due to the detachment of end studs from the track (Figure 6(b)).

Figure 6: Post-test inspection after removal of gypsum board: (a) damage in the wall with telescoping detailing; (b) damage in the wall with a slip track connection

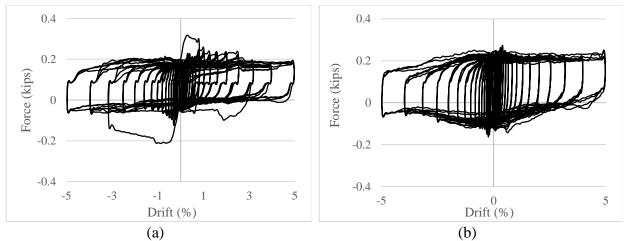
Figure 7 shows the hysteresis loops of the walls with slip-track connection (Figure 7(a)), and telescoping detailing (Figure 7(b)). The hysteresis loops show that both walls developed approximately similar forces because both walls have slip behavior at the top. Moreover, the

hysteresis loops suggest that the out-of-plane drift of the drywall partition does not affect the inplane force of the wall considerably. The slip track wall hysteresis loops exhibited a few sudden increases in the force, which coincided with the occurrence of damage to the framing of this wall mentioned earlier.

Figure 7: Force vs. displacement hysteresis of drywall partition walls: (a) slip track detailing; (b) telescoping detailing

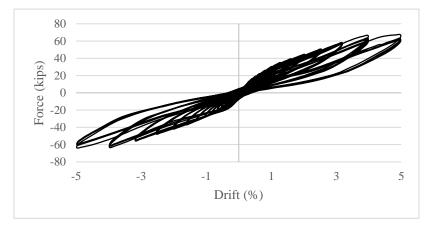
Moreover, the hysteresis loops of the entire subassembly are shown in Figure 8. Since the drywall partition walls had slip behavior, they contributed less than 1% to the whole subassembly force. It is worthwhile to mention that the structural subassembly suffered almost damage. The CLT rocking wall was protected at the toes with steel armoring; therefore, visible damage was limited to crushing of the concrete base beneath the toes of the rocking wall.

Figure 8: Hysteresis loops of the entire subassembly in the in-plane direction
