NHERI TallWood

Shake Table Testing of a Full-Scale Resilient 10-Story Mass-Timber Building Newsletter Issue 4: January 5, 2023

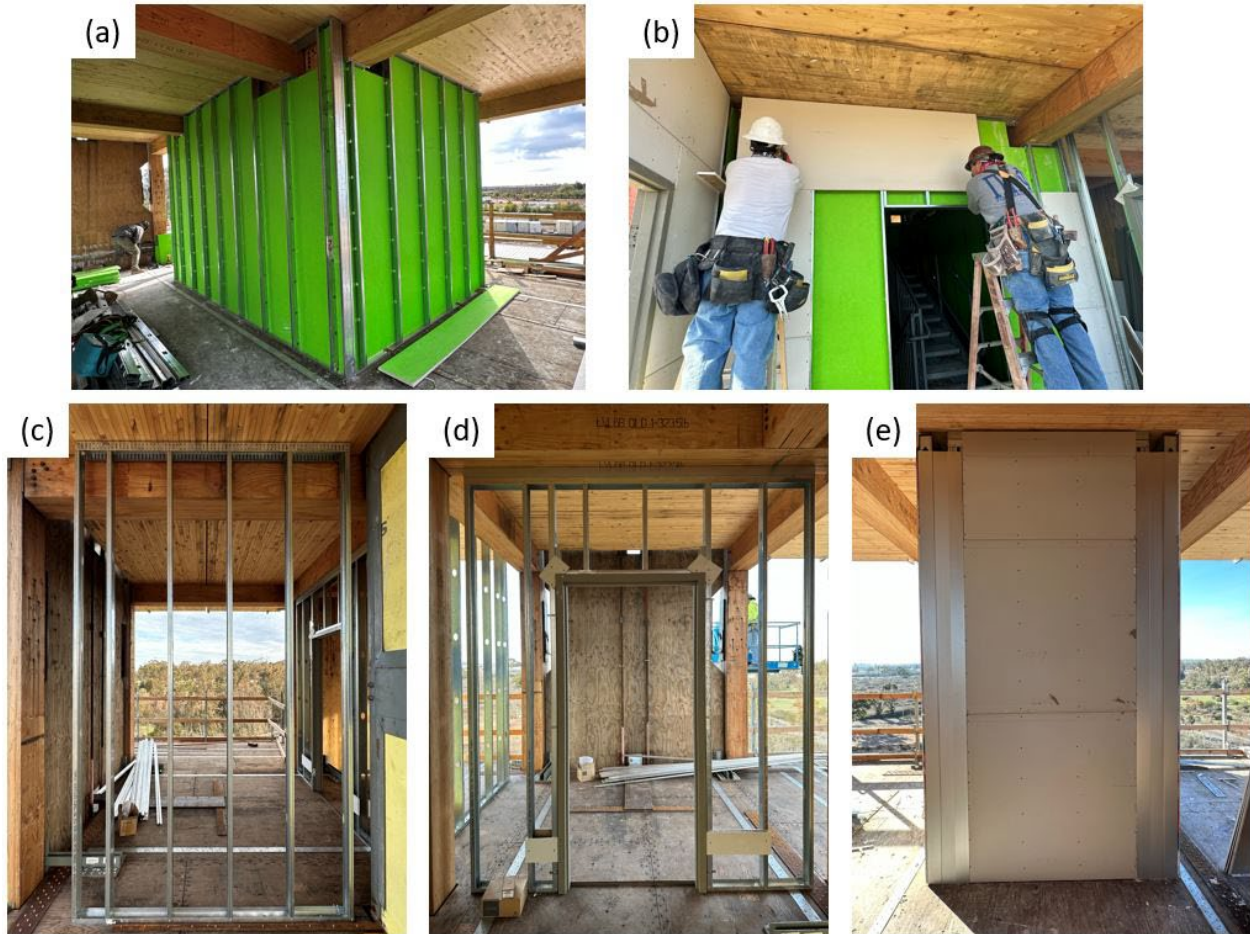
Figure 3: Interior wall construction: (a) shaft wall outline, (b) – (d) various wall junctions with gaps for vertical joints (not yet installed), (e) finished wall with corner joint assembly.

At the same time, Pacific Coast Drywall is finishing the installation of CFS-framed interior walls on three levels. Like the exterior subassemblies, these interior walls utilize techniques to accommodate the floor-to-floor movement, including horizontal slip joints at the top of the wall, and vertical expansion joints to accommodate the displacement incompatibilities at intersecting walls (see Figure 3). Solutions are proposed for a fire-rated shaft wall adjoining to conventional interior partition walls.

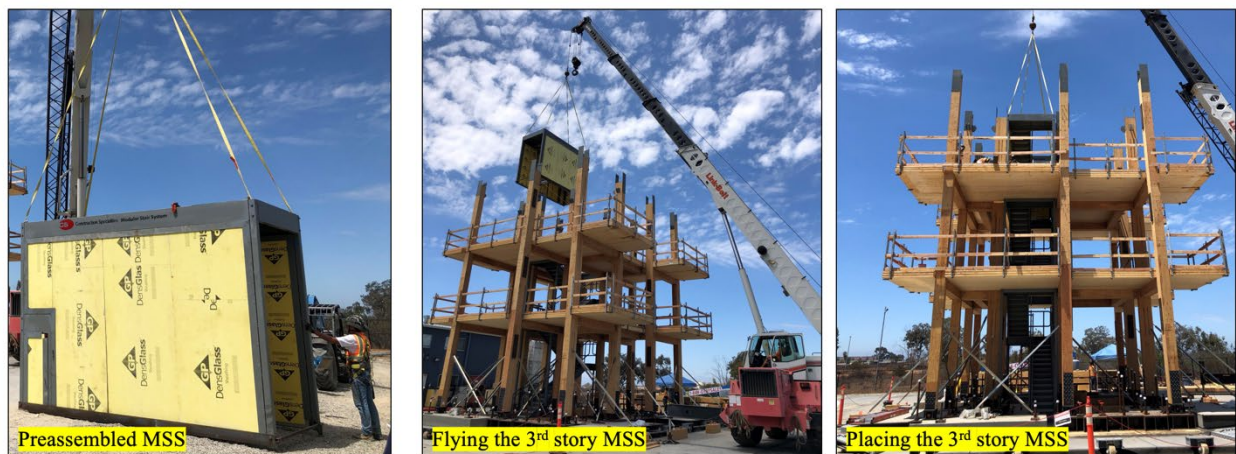
Figure 5: Installation sequence of modular stair system (MSS) unit with fire-rated shaft wall panels
