NHERI TALLWOOD PROJECT

Updates 2020

NHERI TallWood Team

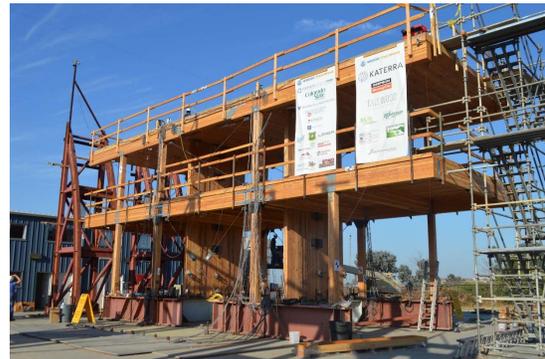
Two-story building tested during Summer of 2017

- We completed a 2-story building test with PT CLT rocking walls in 2017.
- All results and publications now available on Project Website
- Main take-away:
 - The structural system can be damage free at all DBE and some MCE shakes
 - Numerical model works
 - Prototype connections and detailing work
 - Collaboration is key to get this done

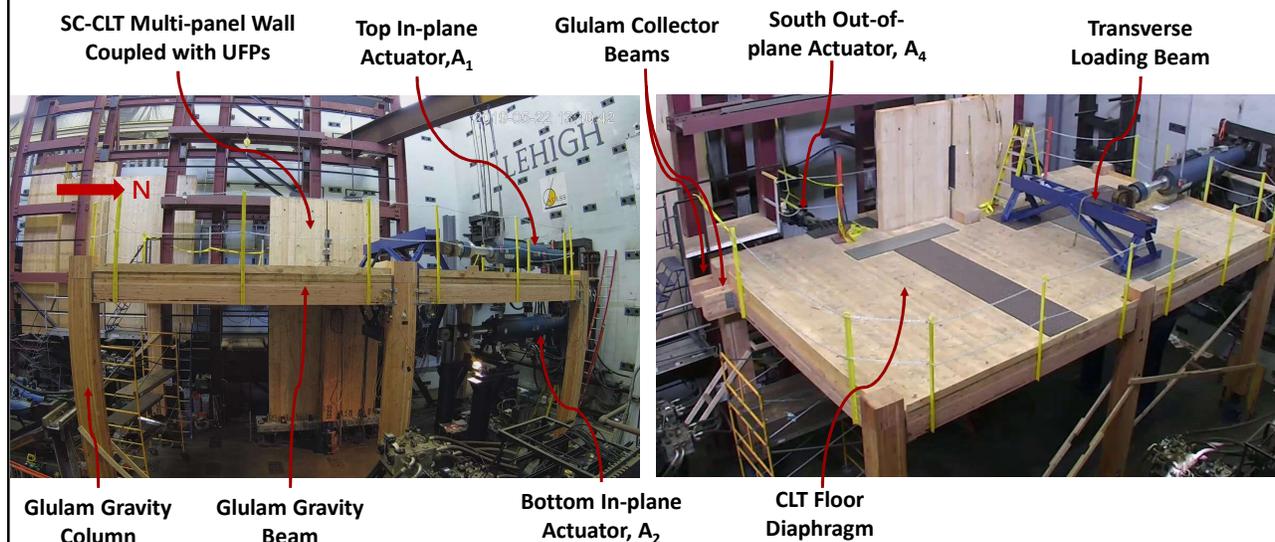
Lehigh Biaxial Test Sub-assembly

- Building Assembly Testing Task
 - Assemble the proposed rocking wall - floor system and conduct loading tests to study the effects of biaxial loading on the structural and non-structural assembly
- Led by Lehigh Team

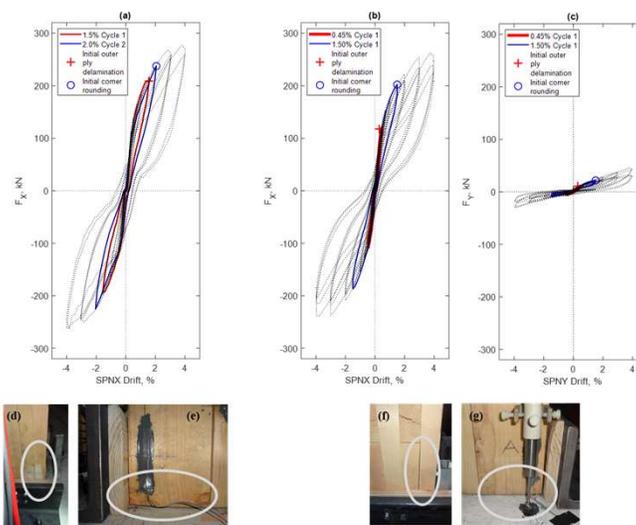
Preliminary results (Sause et al. 2020)

Sause, R., Ricles, J., Amer, A., and Marullo, T. (2020). Multi-directional cyclic testing of cross-laminated timber rocking wall-floor diaphragm sub-assemblies. Proceedings of the 17th World Conference on Earthquake Engineering, September 13-18, Sendai, Japan, 2020

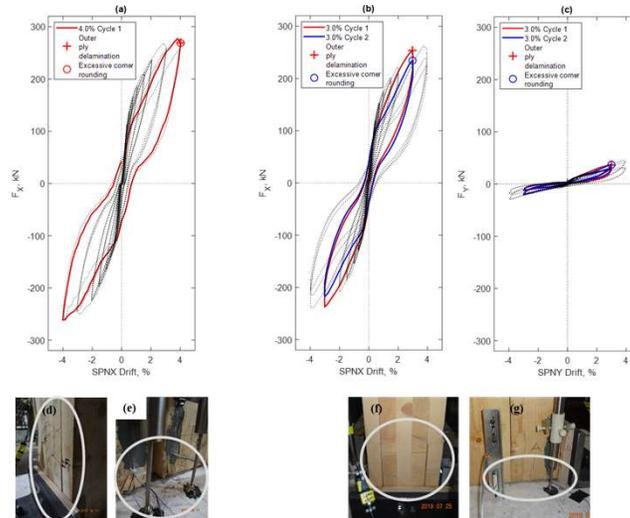
Preliminary results (Sause et al. 2020)

Sause, R., Ricles, J., Amer, A., and Marullo, T. (2020). Multi-directional cyclic testing of cross-laminated timber rocking wall-floor diaphragm sub-assemblies. Proceedings of the 17th World Conference on Earthquake Engineering, September 13-18, Sendai, Japan, 2020

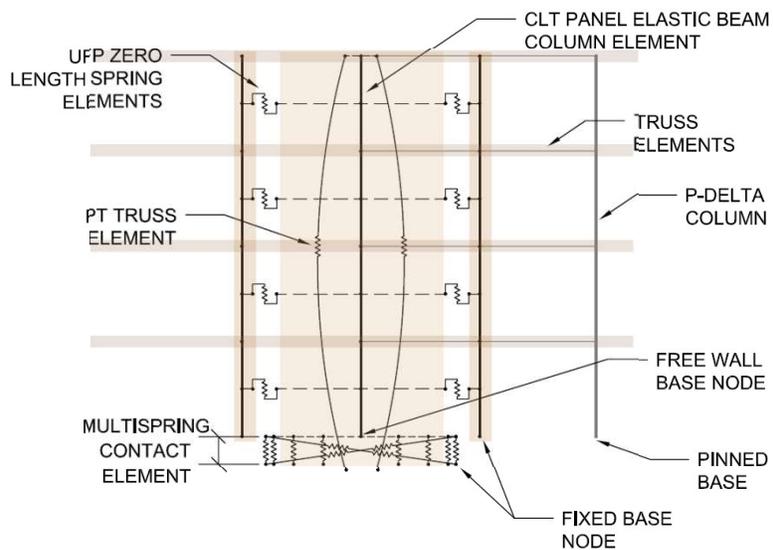
10 Story Modeling Approach

- Numerical modeling Task
 - Developing numerical models for tall wood building with post-tensioned rocking wall systems to be used for design and dynamic response prediction
- Led by University of Washington Team

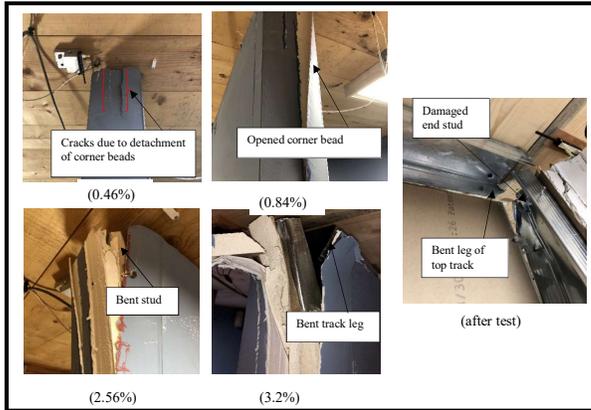
Slip-track detailing

Brief Outcomes Report of Nonstructural Wall Tests at Lehigh Slip Track vs. Telescoping Slip Detailing in a Straight Wall

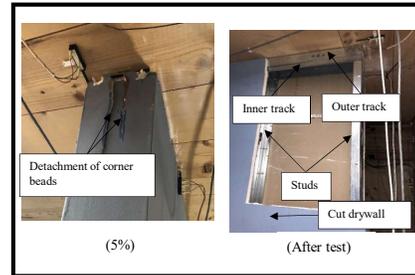
Telescoping detailing

- Conclusion: Telescoping eliminated typical damage at wall ends. Damage was limited to minor detachment of corner beads.

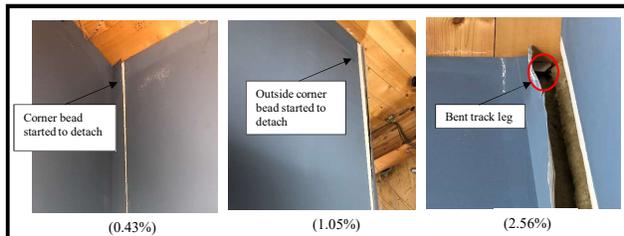
Corner gap

Brief Outcomes Report of Nonstructural Wall Tests at Lehigh Corner Gap vs. Distributed Gap Detailing for Intersections in C-shaped Walls

Significant damage delayed until about 2.5% drift

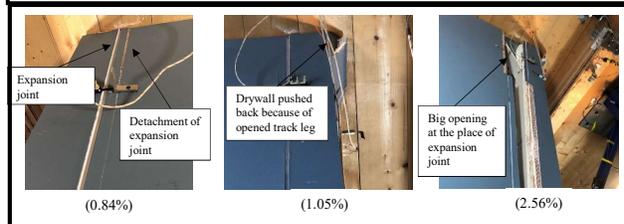
Distributed gap

The onset of damage was postponed to almost 1% drift.

However, the walls separated at the gaps into isolated segments that posed a collapse risk.

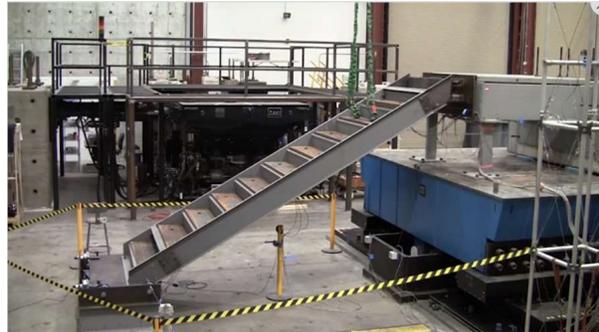
- CS DriftReady™ Stairs detailed with slip joint to accommodate interstory movement
- Details to be explored
 - Incorporation into scissor stairs with intermediate landing
 - Connection to the main structural system
 - Interaction with surrounding fire protection walls

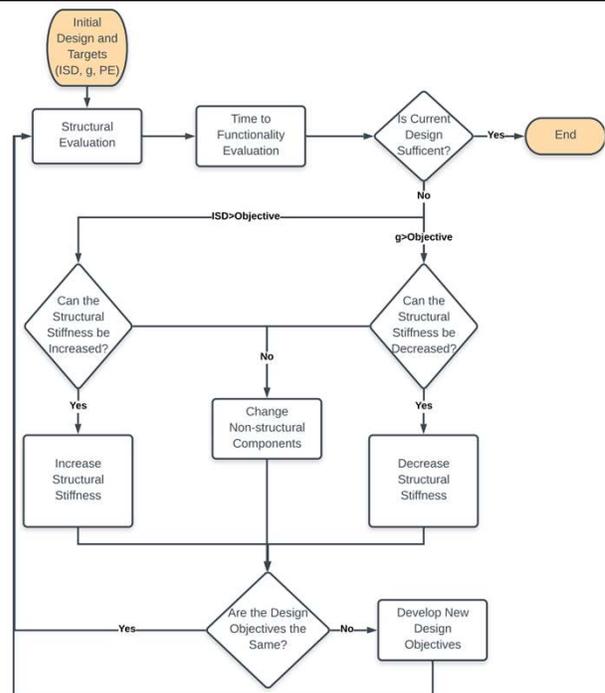
Methodology

- Optimizes Design (Needs Refinement)
 - Considers Structural and Non-Structural Modifications
 - Can Alter Design Objectives to Consider New Design

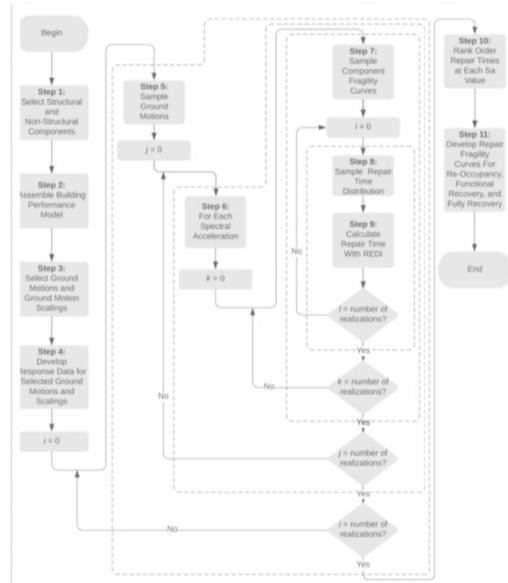
Time to Functionality (Repair Fragility Curves)

- Differences from REdi and PACT
 - Multi-Layered Monte Carlo Used Instead of 90% Repair Value.
 - REdi Repair Methodology is Incorporated into the Multi-Layered Monte Carlo Instead of Using Results from PACT.
 - Instead of Considering 1 Event (such as 2500 MRI), a Variety of Events are Considered
 - Effectively Incorporates REdi and PACT into a Stochastic Simulation

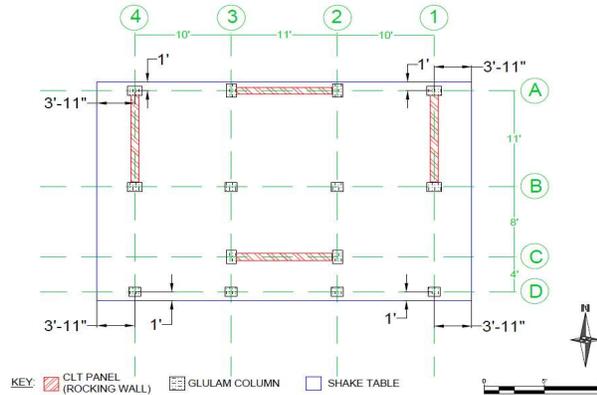
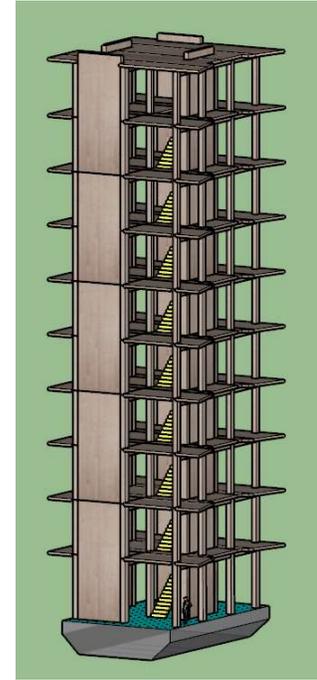
Floor Plan Basics

- UCSD Shake table 25 x 40 ft (7.6 x 12.2 m)
- Building column grid 22 x 31 ft (6.7 x 9.4 m), floor cantilever out

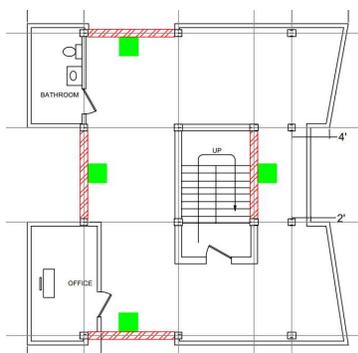
Retail shop (1-2 story)

- Three different Floor usage types

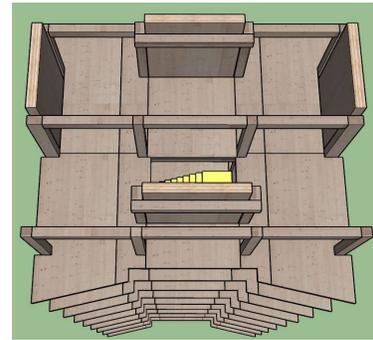
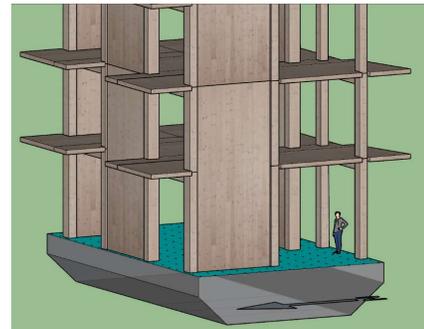
Gravity Design Summary

- Gravity Design following NDS
 - Total floor dead load = 70 lb/sq.ft. (3.35kN/m²)
 - Total floor live load = 65 lb/sq.ft. (3.1 kN/m²)
- Final size of the members
 - Columns (12.25 x 12 ~ 15 in) (31 x 30 ~ 38 cm)
 - Beams (12.25 x 13.5 in) (31 x 34 cm)
 - CLT floor (5-ply CLT, 6 in) (15 cm)
 - Rocking wall panel (9-ply CLT, 12 in) (30 cm)
 - All sizes considering 2-hr fire sacrificial layers (3.6 in) (9 cm)

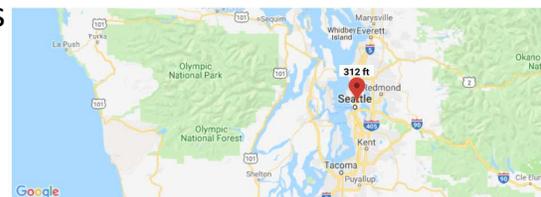
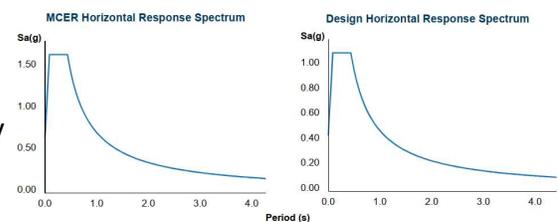
Basic Lateral Design Parameters

- ASCE7-16 Uniformed hazard demands at Seattle WA. Site Class C, Risk Category II
- Seismic weight approximately 70 PSF.
 - The final building specimen will be loaded to this overall weight level using Steel Plates during seismic test.
 - Seismic mass placement in the building will be arranged to minimize eccentricity
- Four rocking walls, 2 in each direction, 2 CLT, 2 MPP.
